**1964 Cessna 210D
N375MK | MSN: 21058252**

On July 30, 2022, N375MK was involved in a pilot-induced gear-up landing. The PIC did not attempt to utilize the emergency manual pump gear extension system.

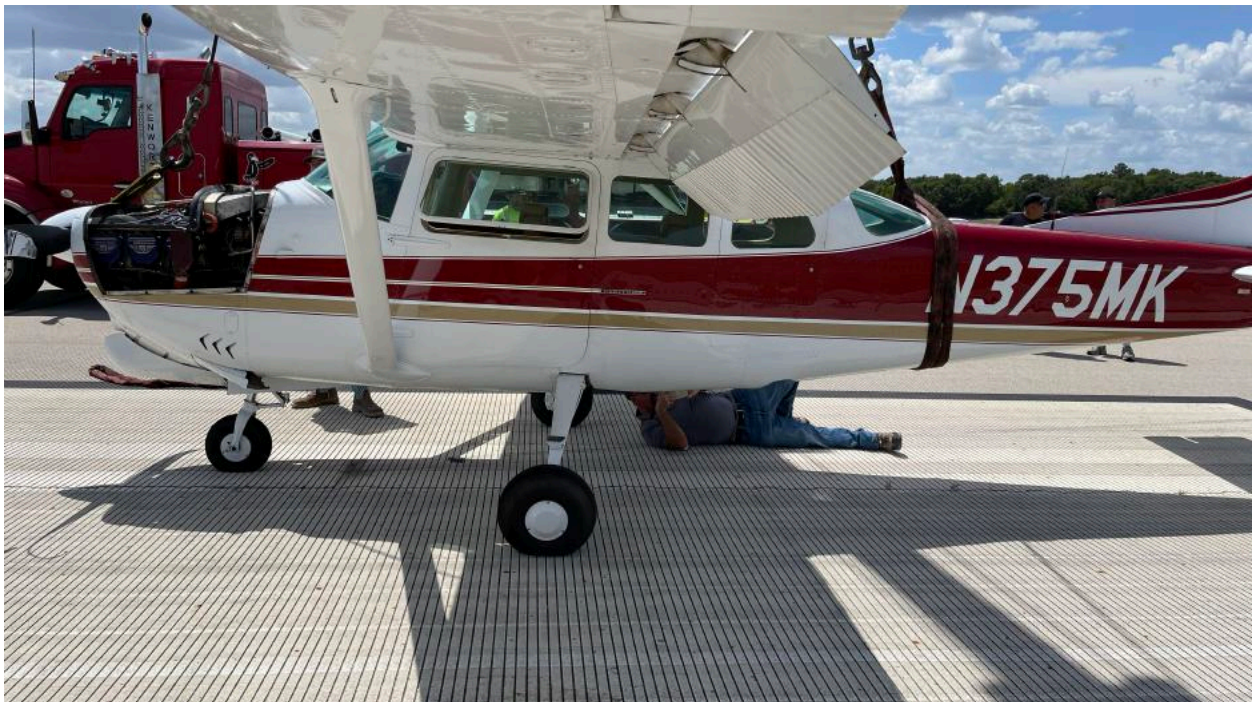
Post-incident investigation showed the hydraulic pump gear extension reservoir was full. The system was then tested and the gear deployed as expected.
